APPENDIX A: Supplemental Figures

APPENDIX B – Brief Summaries of Cases with Neck Injury

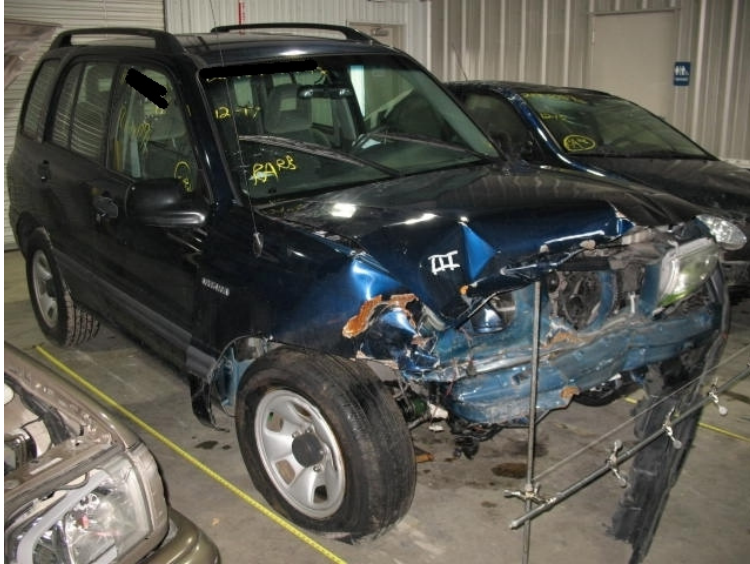
Figure A2. A head-on collision between this 2002 Suzuki Vitara and a passenger car resulted in an estimated 19 km/h delta V (from crash reconstruction) for the Vitara. A 64-year-old female in the left rear seat was fatally injured with AIS 3+ chest and head injuries.

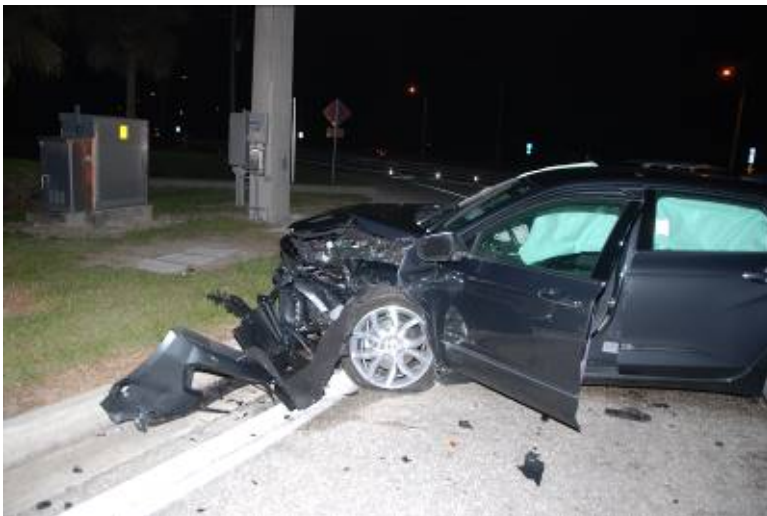
Figure A3. A head-on collision between this 2015 Chevrolet Impala and a passenger car resulted in a 44 km/h longitudinal delta V (from EDR) for the Impala. Both rear-seat occupants, an 84-year-old obese male in the left rear and a 79-year-old obese female in the right rear, were fatally injured with chest and spine injuries.

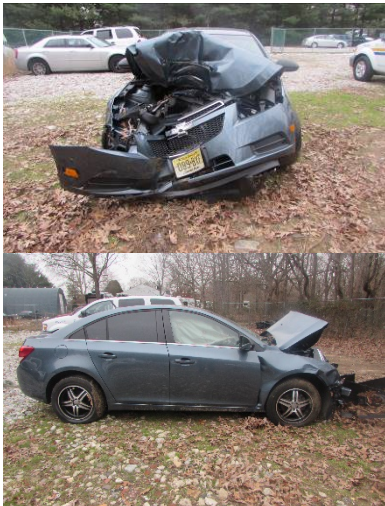
CHOP #82

Case vehicle: Passenger car

Principal crash partner: Wood utility pole

Injuries: Decedent suffered nonspecific neck injury.

Other occupants: All other occupants survived with incapacitating injuries. Fatally injured occupant was the only one properly restrained.

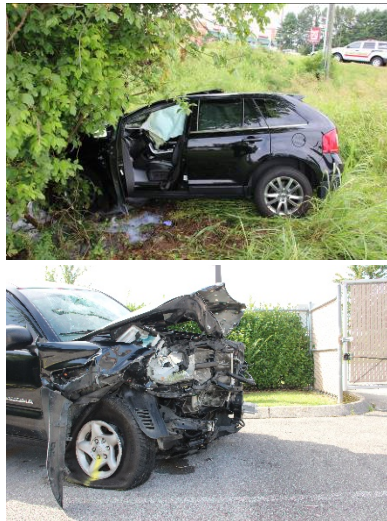
CHOP #109

Case vehicle: SUV
Principal crash partner: Pickup
Occupant age: 77
Occupant sex: F
Restraint: Lap/shoulder
Seat position: 23
Injuries: Multiple blunt force injuries with multiple contusions and abrasions of neck and torso. C1/C2 fracture with complete atlanto-occipital dislocation.
Other occupants: Driver, front-seat passenger, and middle and left rear-seat passengers survived with minor injuries.

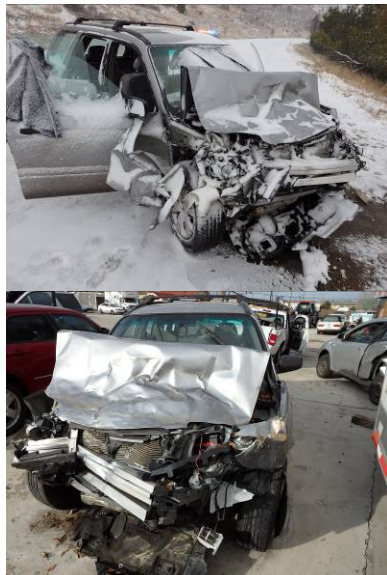
CHOP #110

Case vehicle: SUV
Principal crash partner: SUV
Occupant age: 60
Occupant sex: F
Restraint: Lap/shoulder
Seat position: 23
Injuries: Atlanto-occipital dislocation, subarachnoid hemorrhage, sternum and rib fractures, bilateral hemothoraces, lacerations of liver and mesentery, abrasions and contusions of hand and legs.
Other occupants: Driver survived with visible head injuries, front passenger suffered incapacitating injuries.

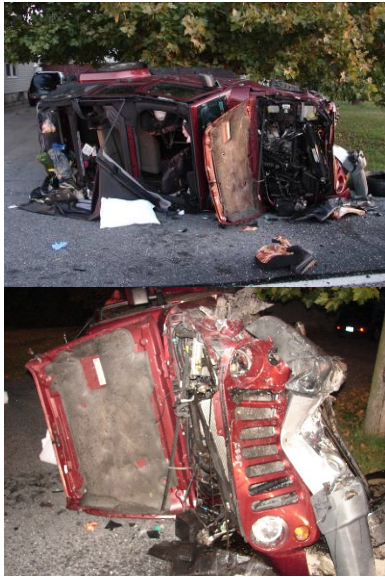
CHOP # 123

Case vehicle: SUV

Principal crash partner: Passenger car

Injuries: Atlanto-occipital dislocation, subarachnoid hemorrhage, bilateral pulmonary contusions, shock bowel, T5 fracture and T4 and T5 flexion injury.

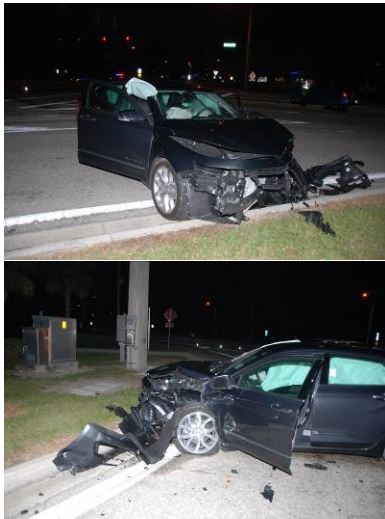
CHOP #157

Case vehicle: Passenger car

Principal crash partner: Passenger car

Injuries: Occipital scalp contusion and right parietal subgaleal hemorrhage, epidural hemorrhage of cervical and proximal thoracic spinal cord, left clavicle and bilateral rib fractures
