GEOLOGICAL MAP

GEOMORPHOLOGICAL CROSS-SECTIONS

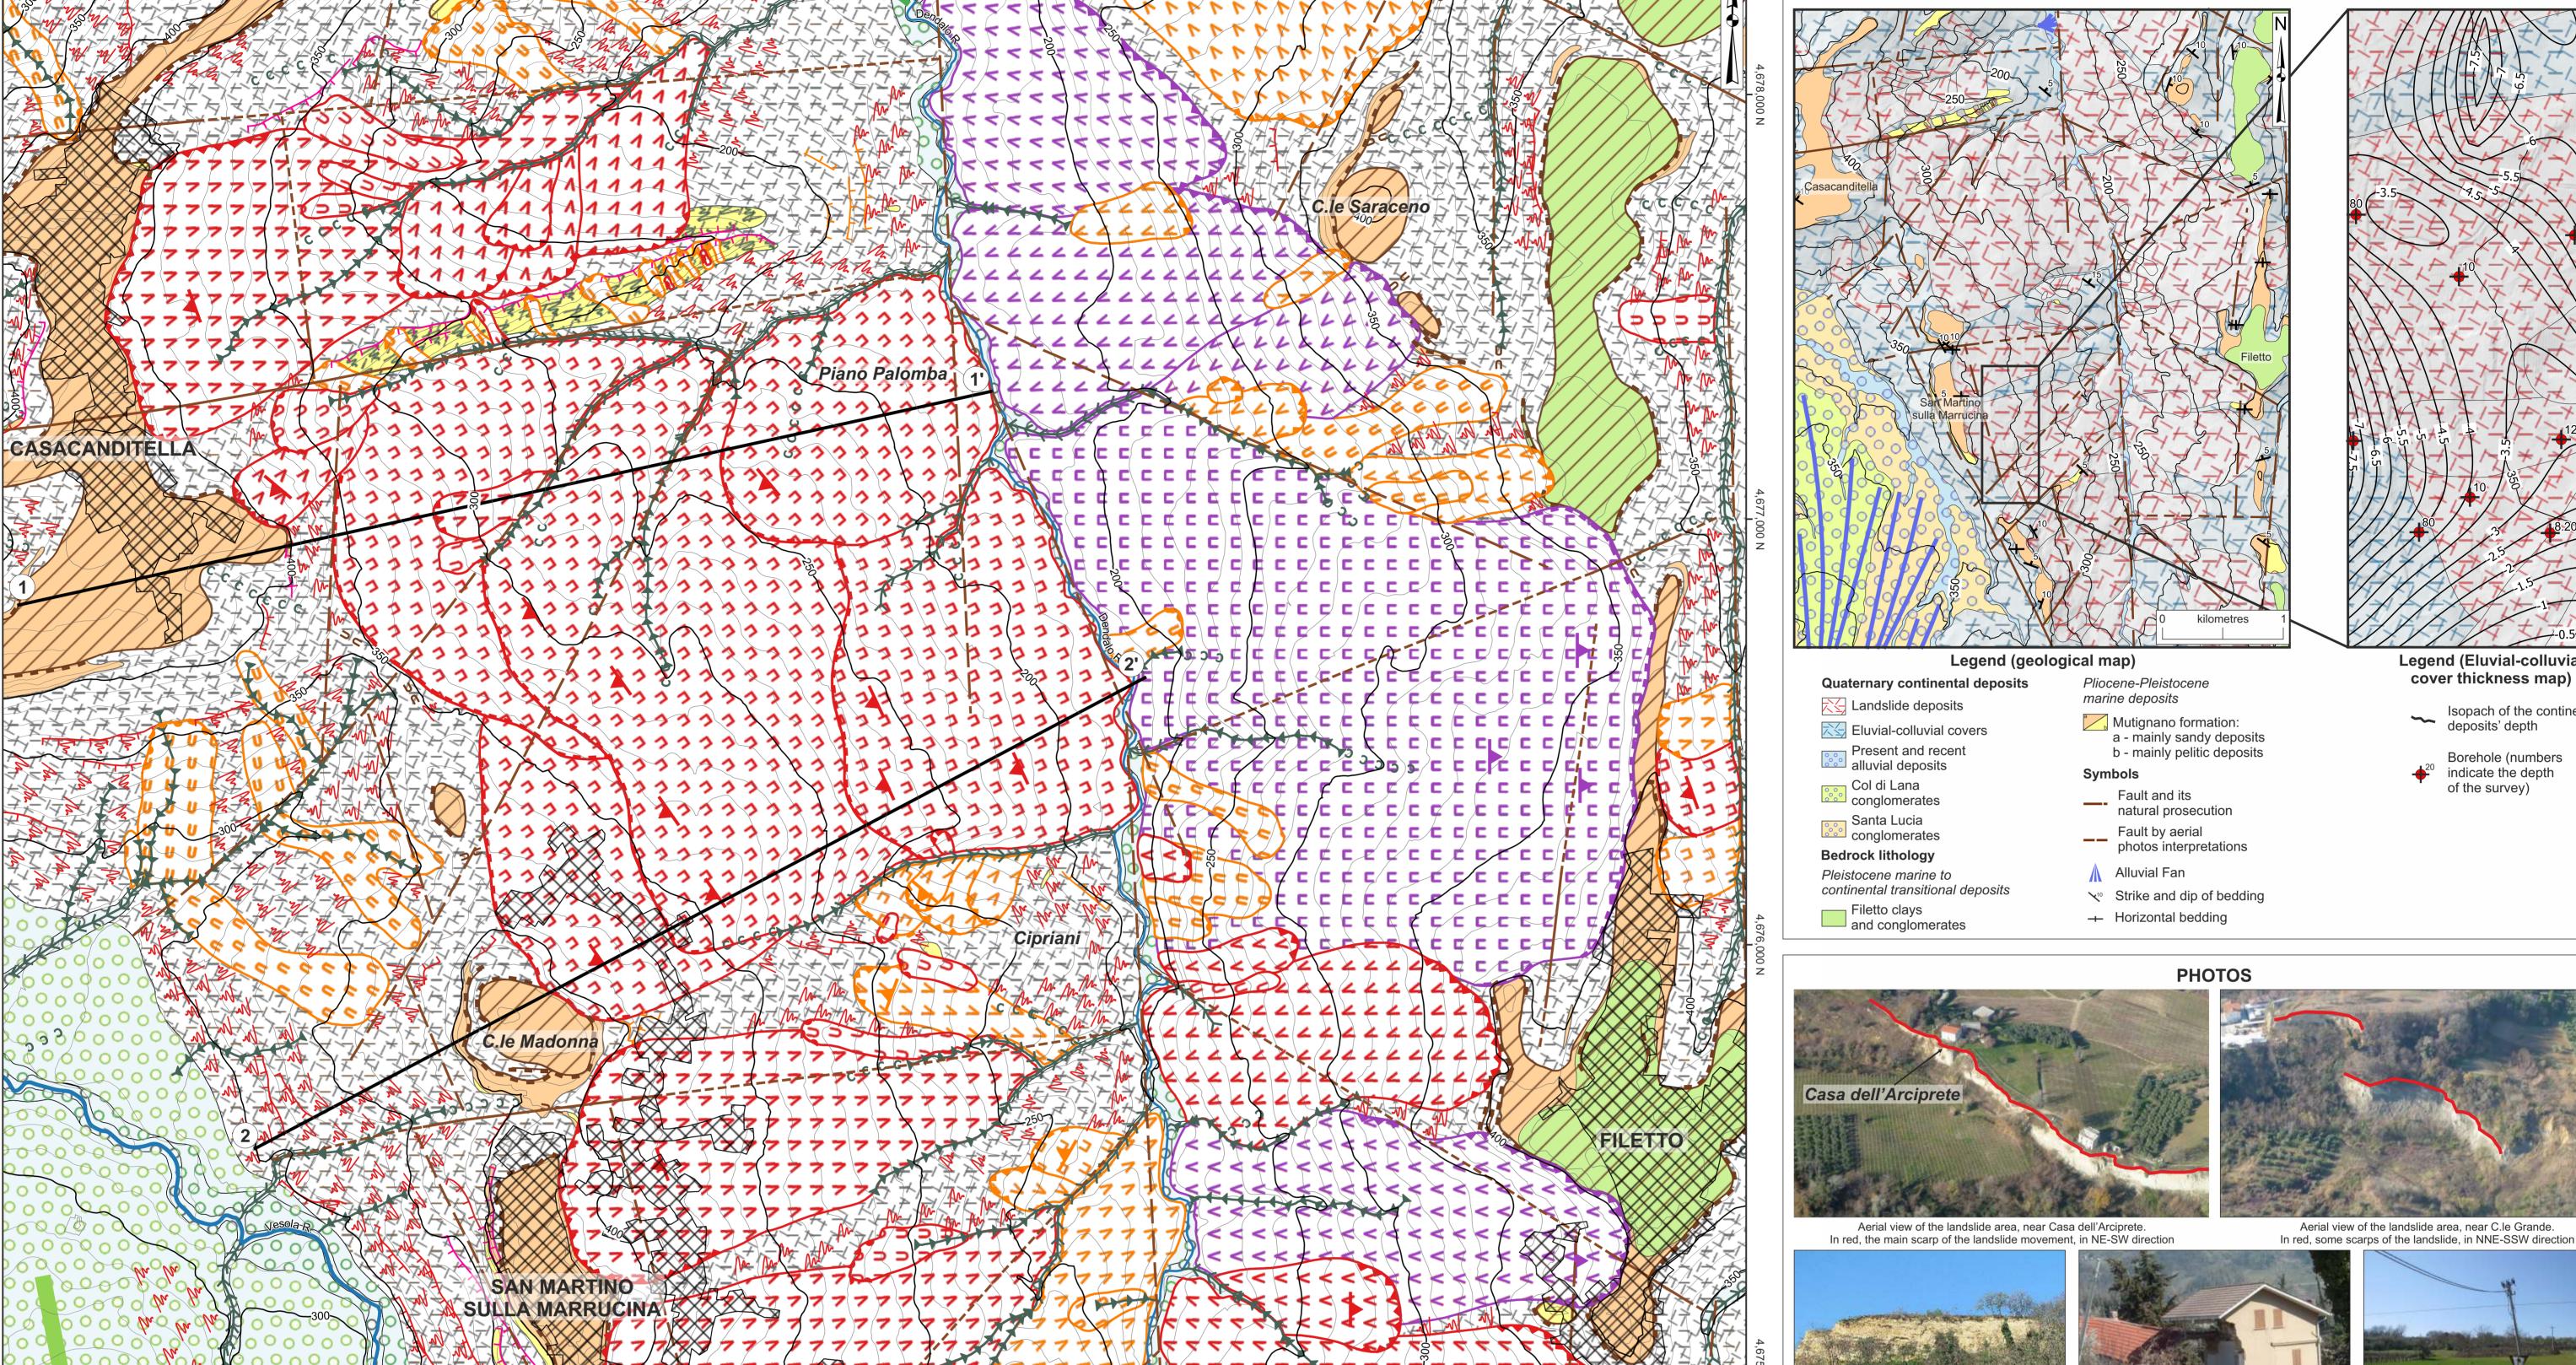
Informations about lithological features and superficial deposit cover are synthesized in these maps. Where available, the thickness of superfiacial deposits was reconstructed through boreholes data; this analysis allowed the generation of the isopach of the top surface of the Pliocene-Pleistocene marine deposits.

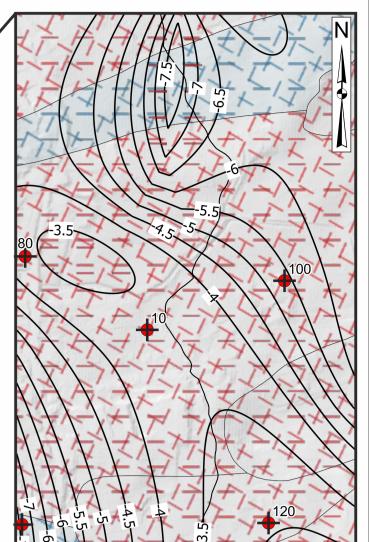
Legend (Eluvial-colluvial

cover thickness map)

Isopach of the continental deposits' depth

Borehole (numbers

indicate the depth

of the survey)

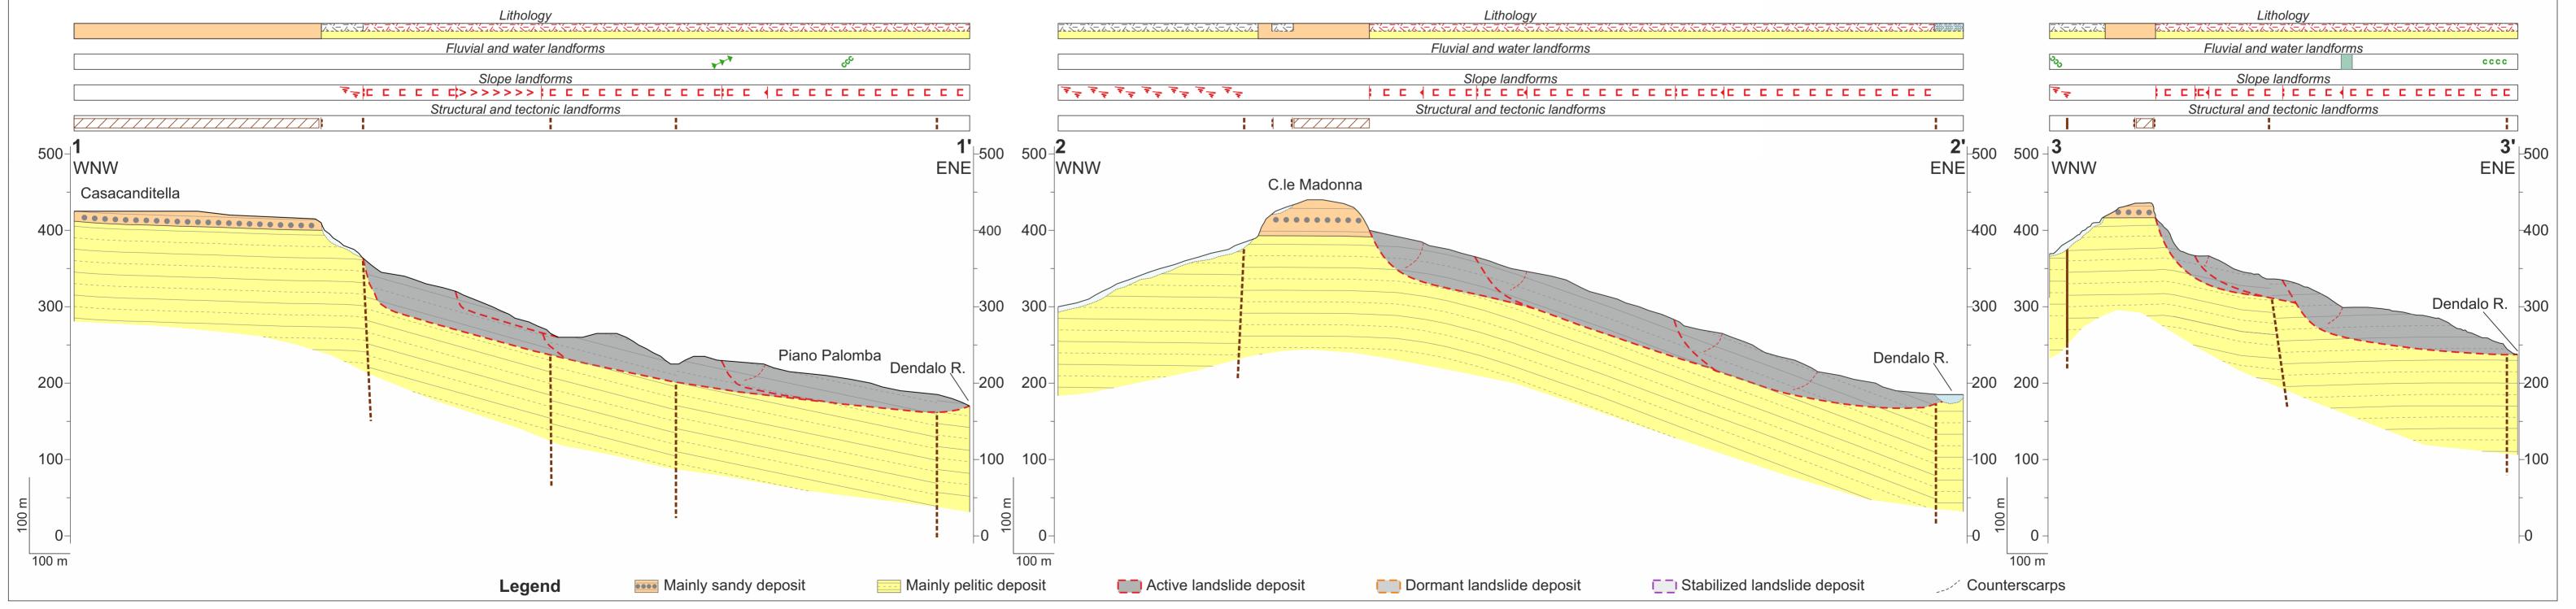
Geomorphological and available stratigraphic information on key areas were synthesized in three cross-sections. The profiles, chosen in order to best indicate the geometry of the bedrock and landslide bodies, clearly show how the landslides are in close connection with each other, often presenting several coalescent bodies.

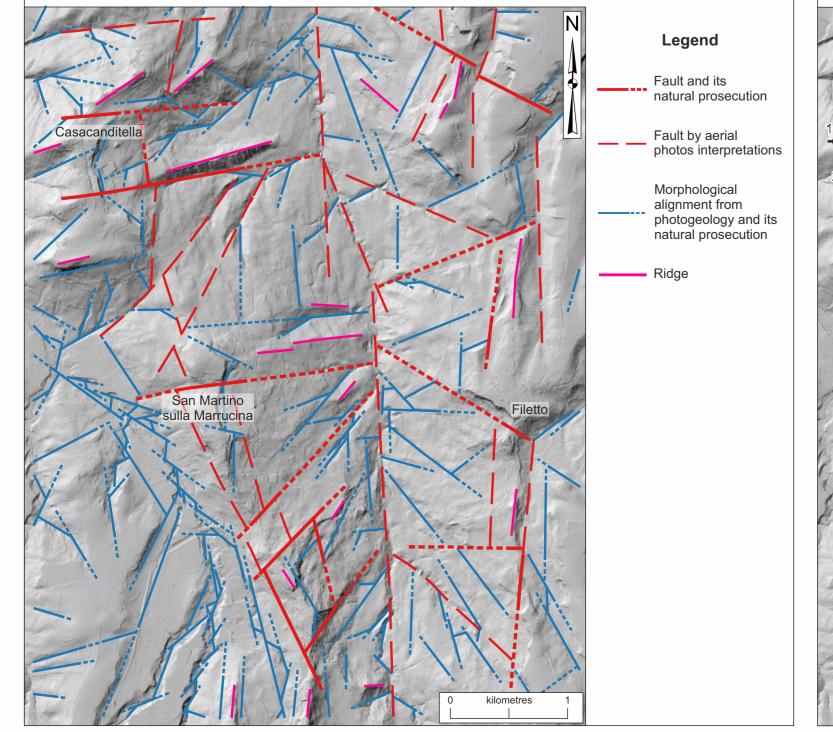
STRUCTURAL SCHEME

The analysis and identification of the main fault alignments were done by using morphological analysis, photointerpretation, and stratigraphic data. The main systems show a N-S, E-W, SW-NE, SE-NW, and SSE-NNW trend.

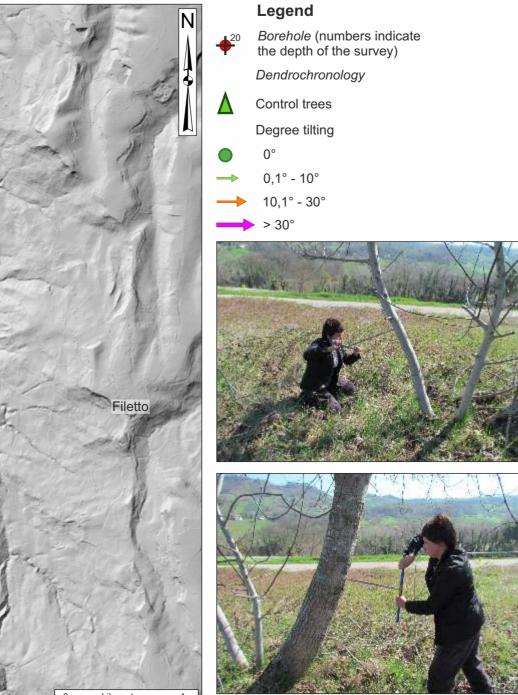
BOREHOLE AND DENDROCHRONOLOGY

Information on lithology and thickness of bedrock and superficial deposits were achieved through the analysis of boreholes. Dendrochronology was used to analyse the evolution of the complex landslide. Trees located in the central part, clearly showed more than one growth stress.

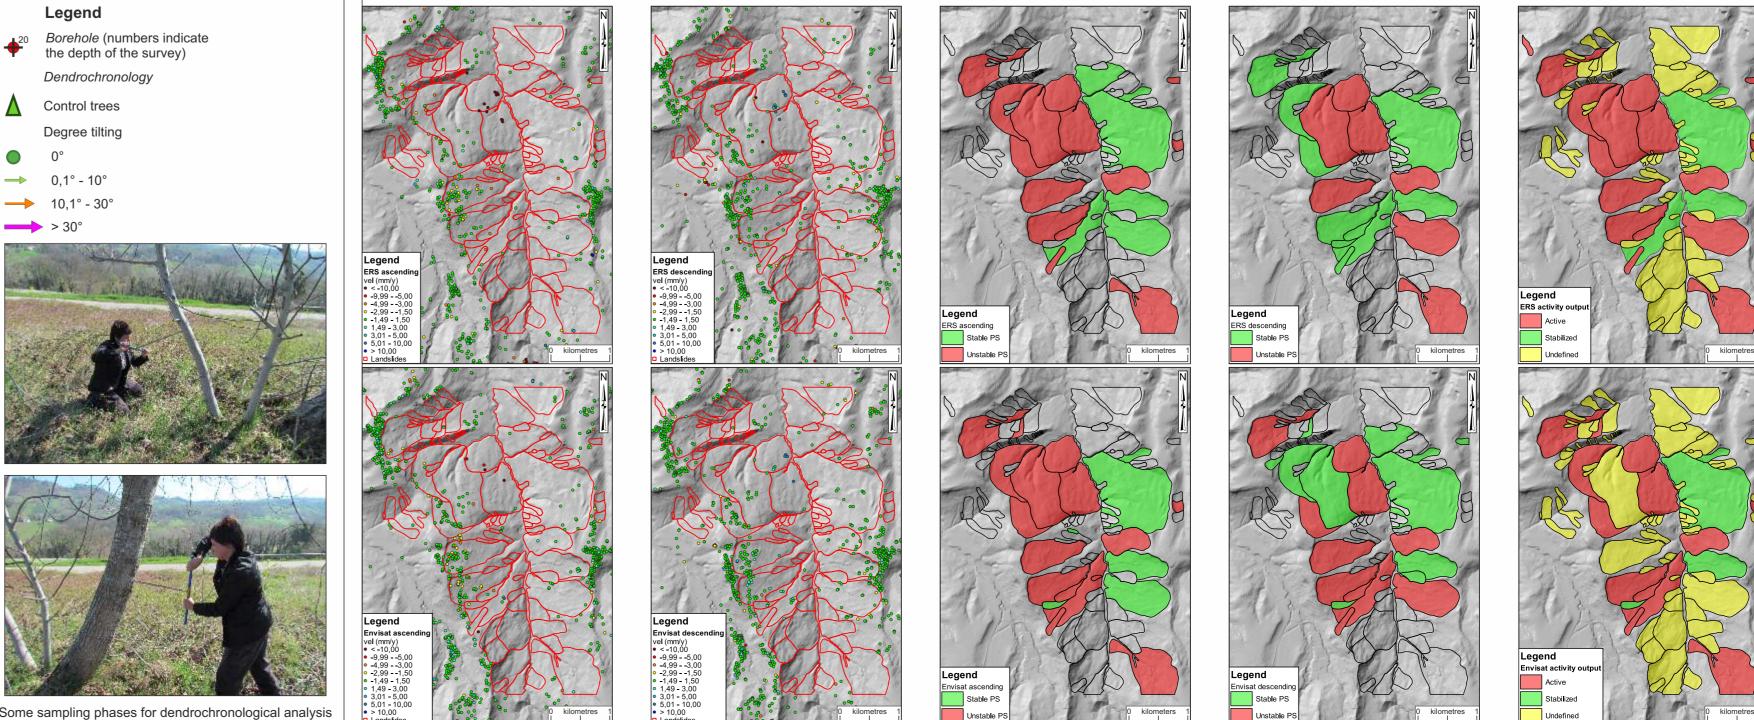
INTERFEROMETRY (modified from Bozzano et al., 2017)

Interferometric analysis was performed using ERS and Envisat data, which provided quantitative information about spatial and temporal evolution of landslides. The maps enabled the observation of the deformation affecting the study area, through the detection of targets affected by vertical displacement (mm/year). The displacement rates analysis allow to discriminate stable and unstable landslides areas in a 18-year period (1992-2010), in order to understand the landslide state of activity.
