1 **Supplemental material for**
2 **Anti-biofilm activity of a novel pit and fissure self-adhesive sealant**
3 **modified with metallic monomers**

4 Alexandra Rubin Cocco^{1,2}, Carlos Enrique Cuevas-Suárez¹, Yuan Liu²,
5 Rafael Guerra Lund¹, Evandro Piva^{1,*}, Geelsu Hwang^{2,3,4,*}

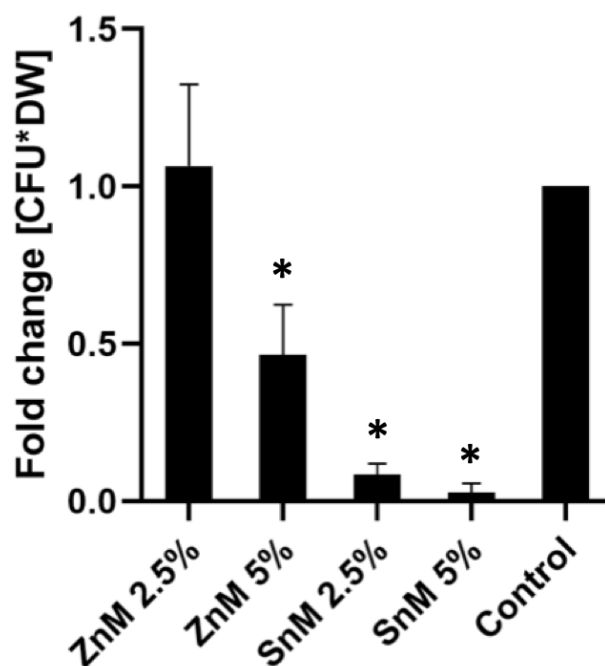
21 **Supplemental material figure S1.** Fold changes of CFU*DW of 42 h old
 22 *Streptococcus mutans* biofilms formed on each surface. * indicates that the values are
 23 significantly different from those of the control surface ($p < 0.05$) (n=4).

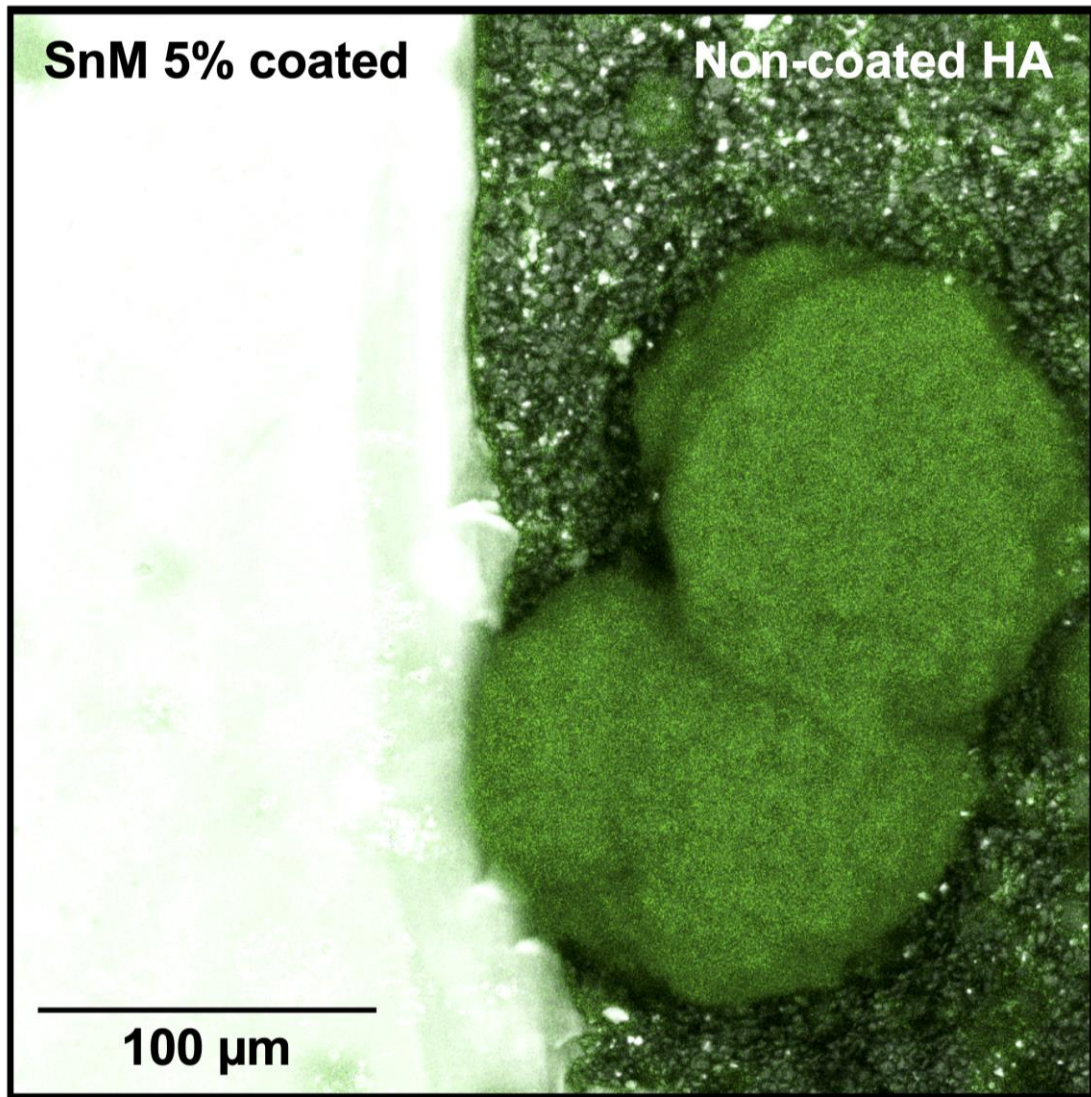
25
26 **Supplemental material figure S2.** Representative confocal images of 42 h old
27 *Streptococcus mutans* single-species biofilms formed on hydroxyapatite (HA) disc with
28 or without SnM 5% coating. There are no visible biofilms formed on SnM 5% coated
29 area (white), while sizeable microcolonies were observed on the non-coated bare HA
30 disc surface.
